CULTURAL RESOURCES SURVEY OF
THE SCE&G SALUDA DAM COMPLEX,
LEXINGTON COUNTY, SOUTH CAROLINA

CHICORA RESEARCH CONTRIBUTION 306

Prepared By:
Michael Trinkley, Ph.D.

January 8, 2001

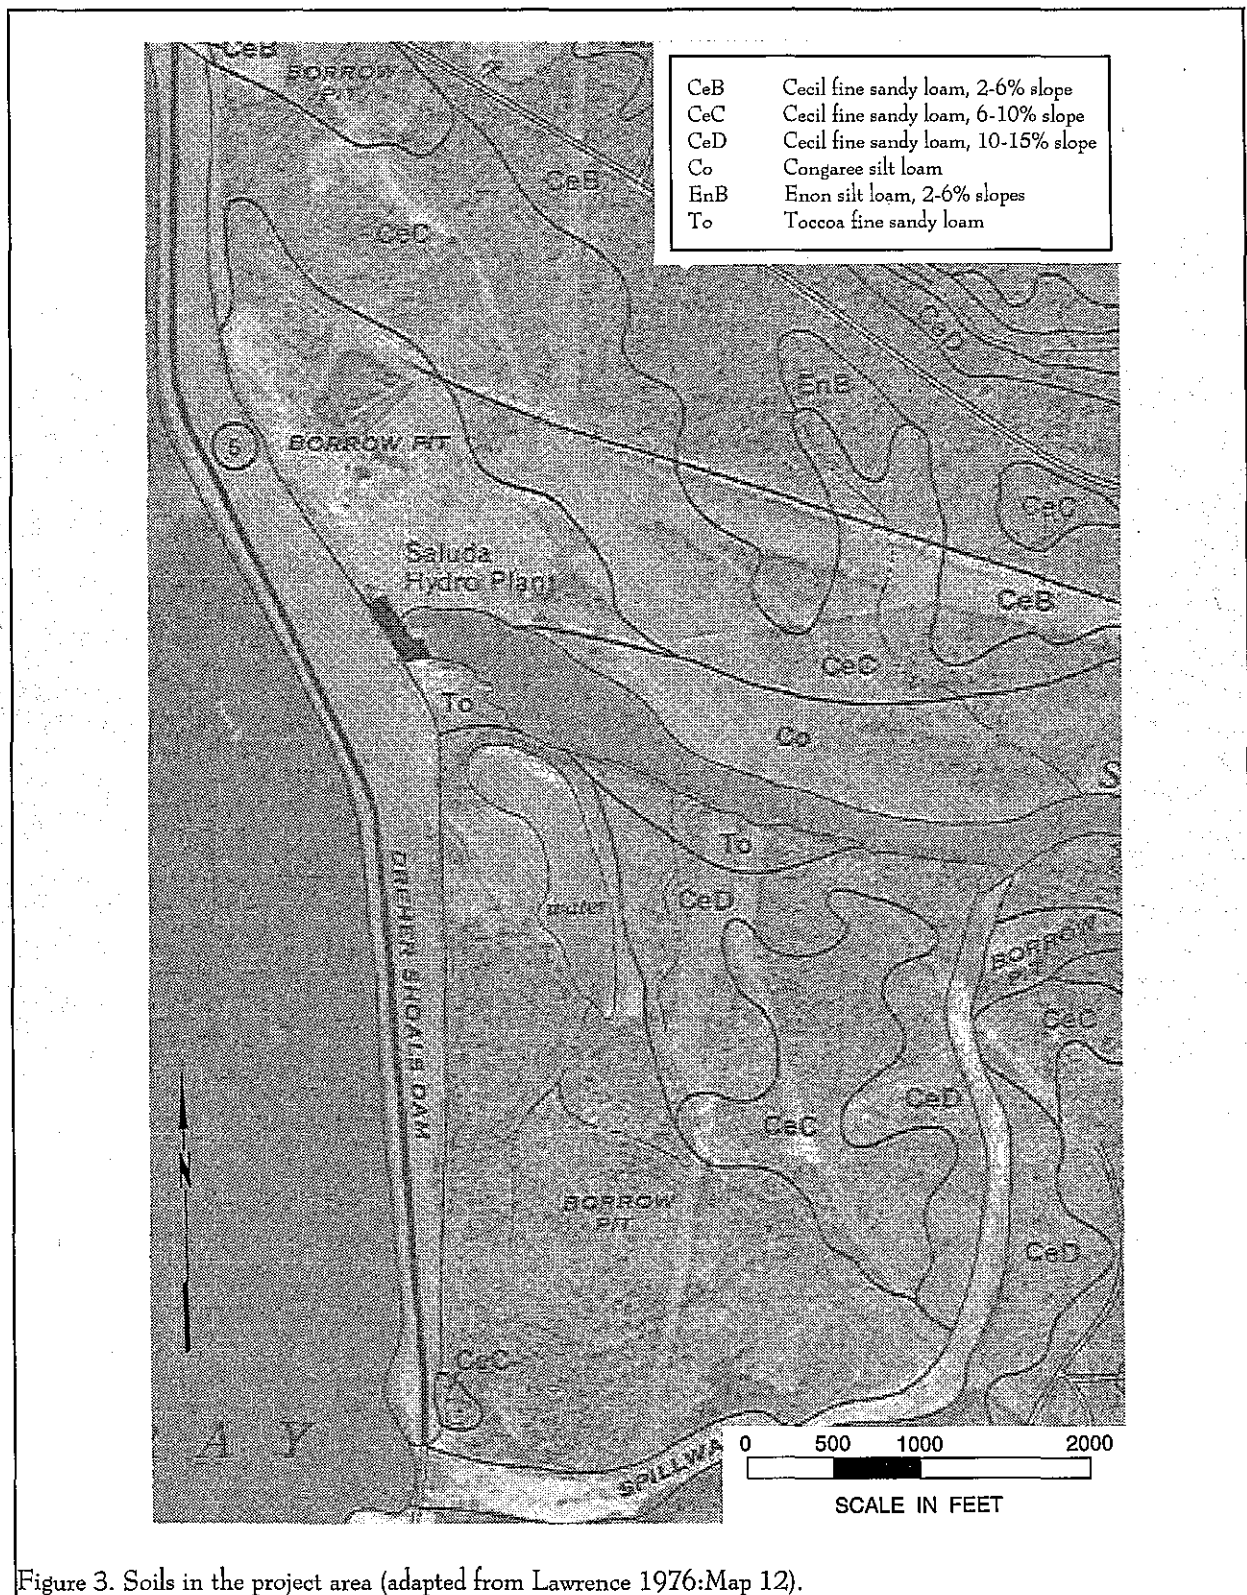
Figure 3. Soils in the project area (adapted from Lawrence 1976:Map 12).

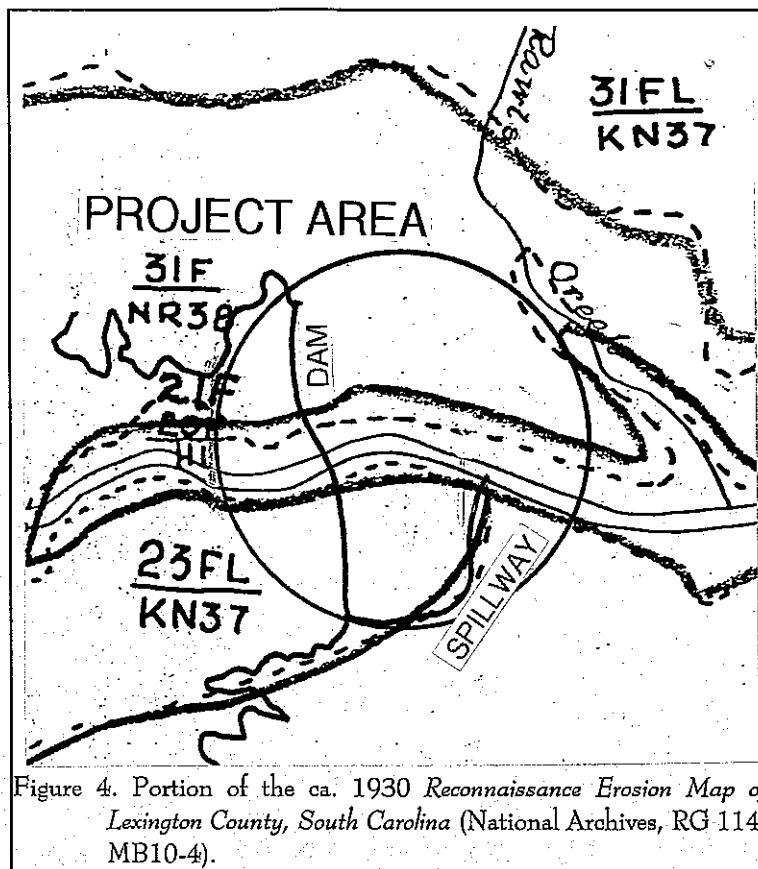
Figure 4. Portion of the ca. 1930 *Reconnaissance Erosion Map of Lexington County, South Carolina* (National Archives, RG 114, MB10-4).

A far more detailed assessment of the soils in this area is provided by the undated (ca. 1930) *Reconnaissance Erosion Map of Lexington County*, produced by M.W. Lowry and C.B. Gay (National Archives, RG 114, MB10-4). This map (Figure 4) reveals that all of the area on the north side of the Saluda River was classified as "Severe Sheet Erosion Frequent Gullies," while on the south side the condition was only marginally better, with the soils identified as "Severe Sheet Erosion Occasional Gullies."

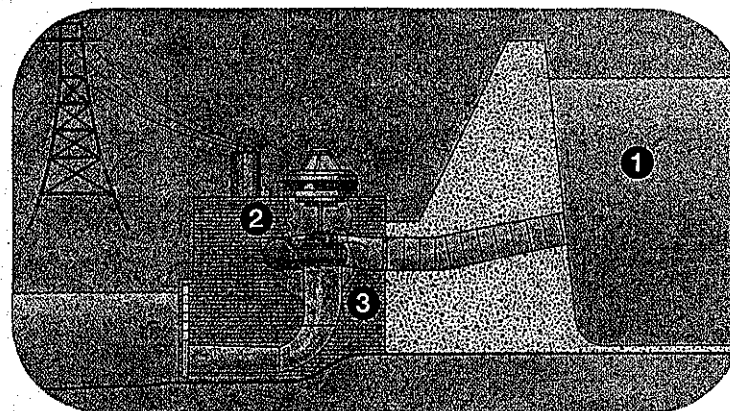
1. Water held in the reservoir behind a dam is allowed to enter the powerhouse through penstocks.
2. Water turns the turbine generator producing electricity.
3. The water is then released.

Figure 16. Operation of hydroelectric and fossil fuel plants (adapted from "SCE&G Generation").

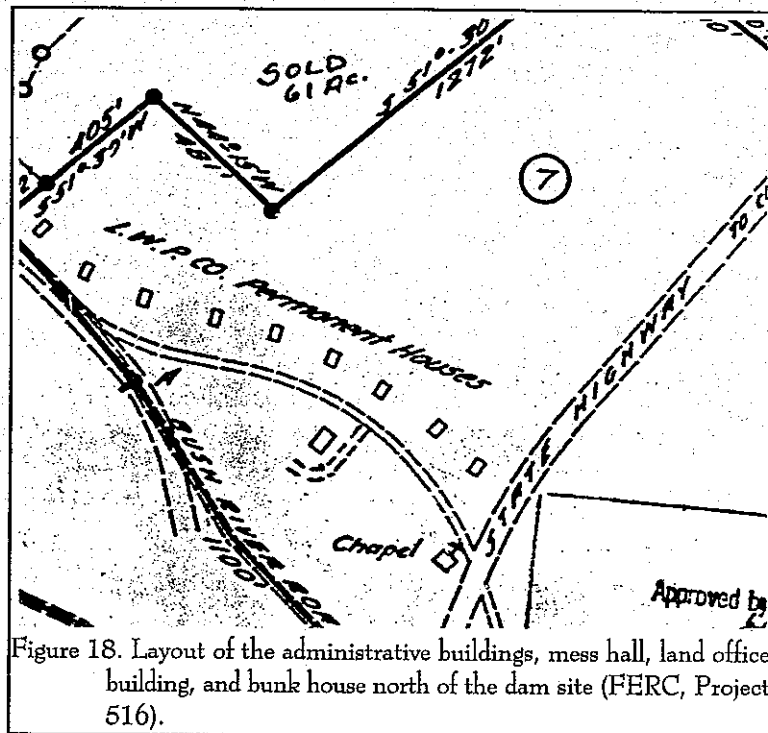
Figure 18. Layout of the administrative buildings, mess hall, land office building, and bunk house north of the dam site (FERC, Project 516).

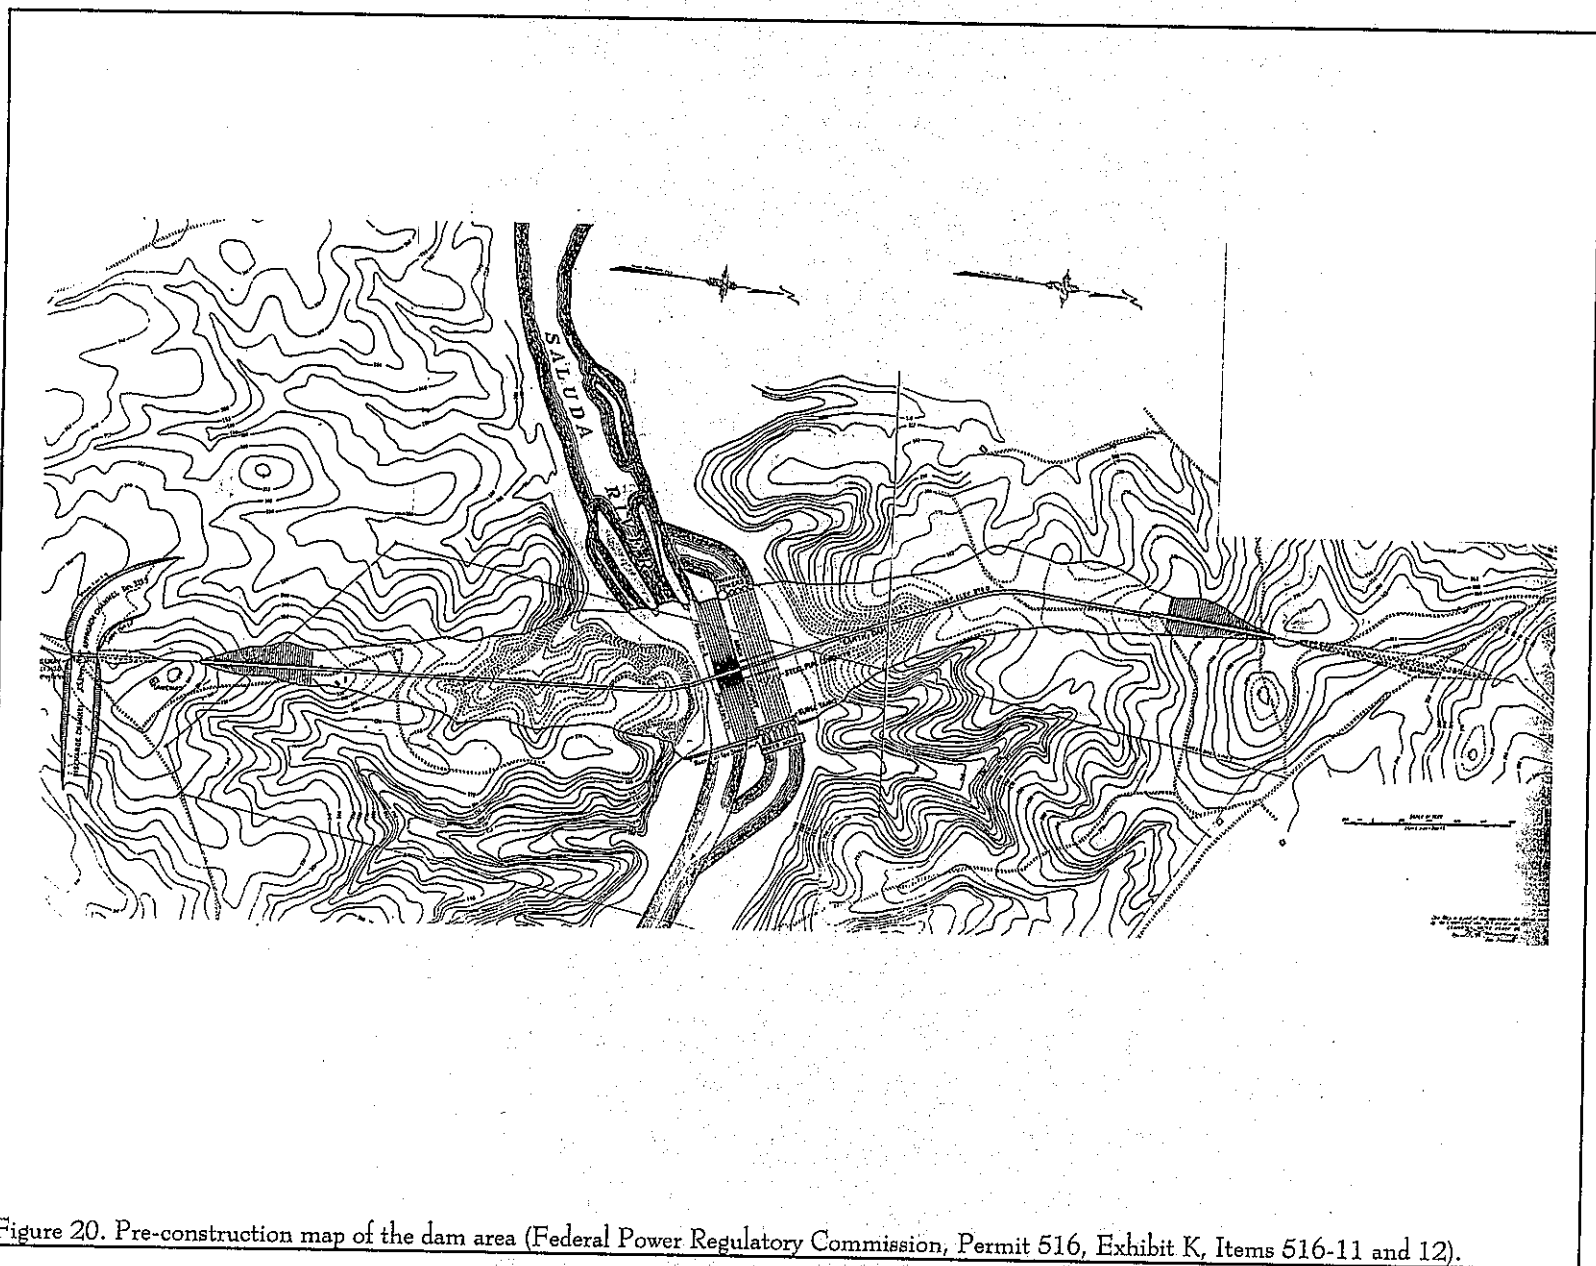
Figure 20. Pre-construction map of the dam area (Federal Power Regulatory Commission, Permit 516, Exhibit K, Items 516-11 and 12).

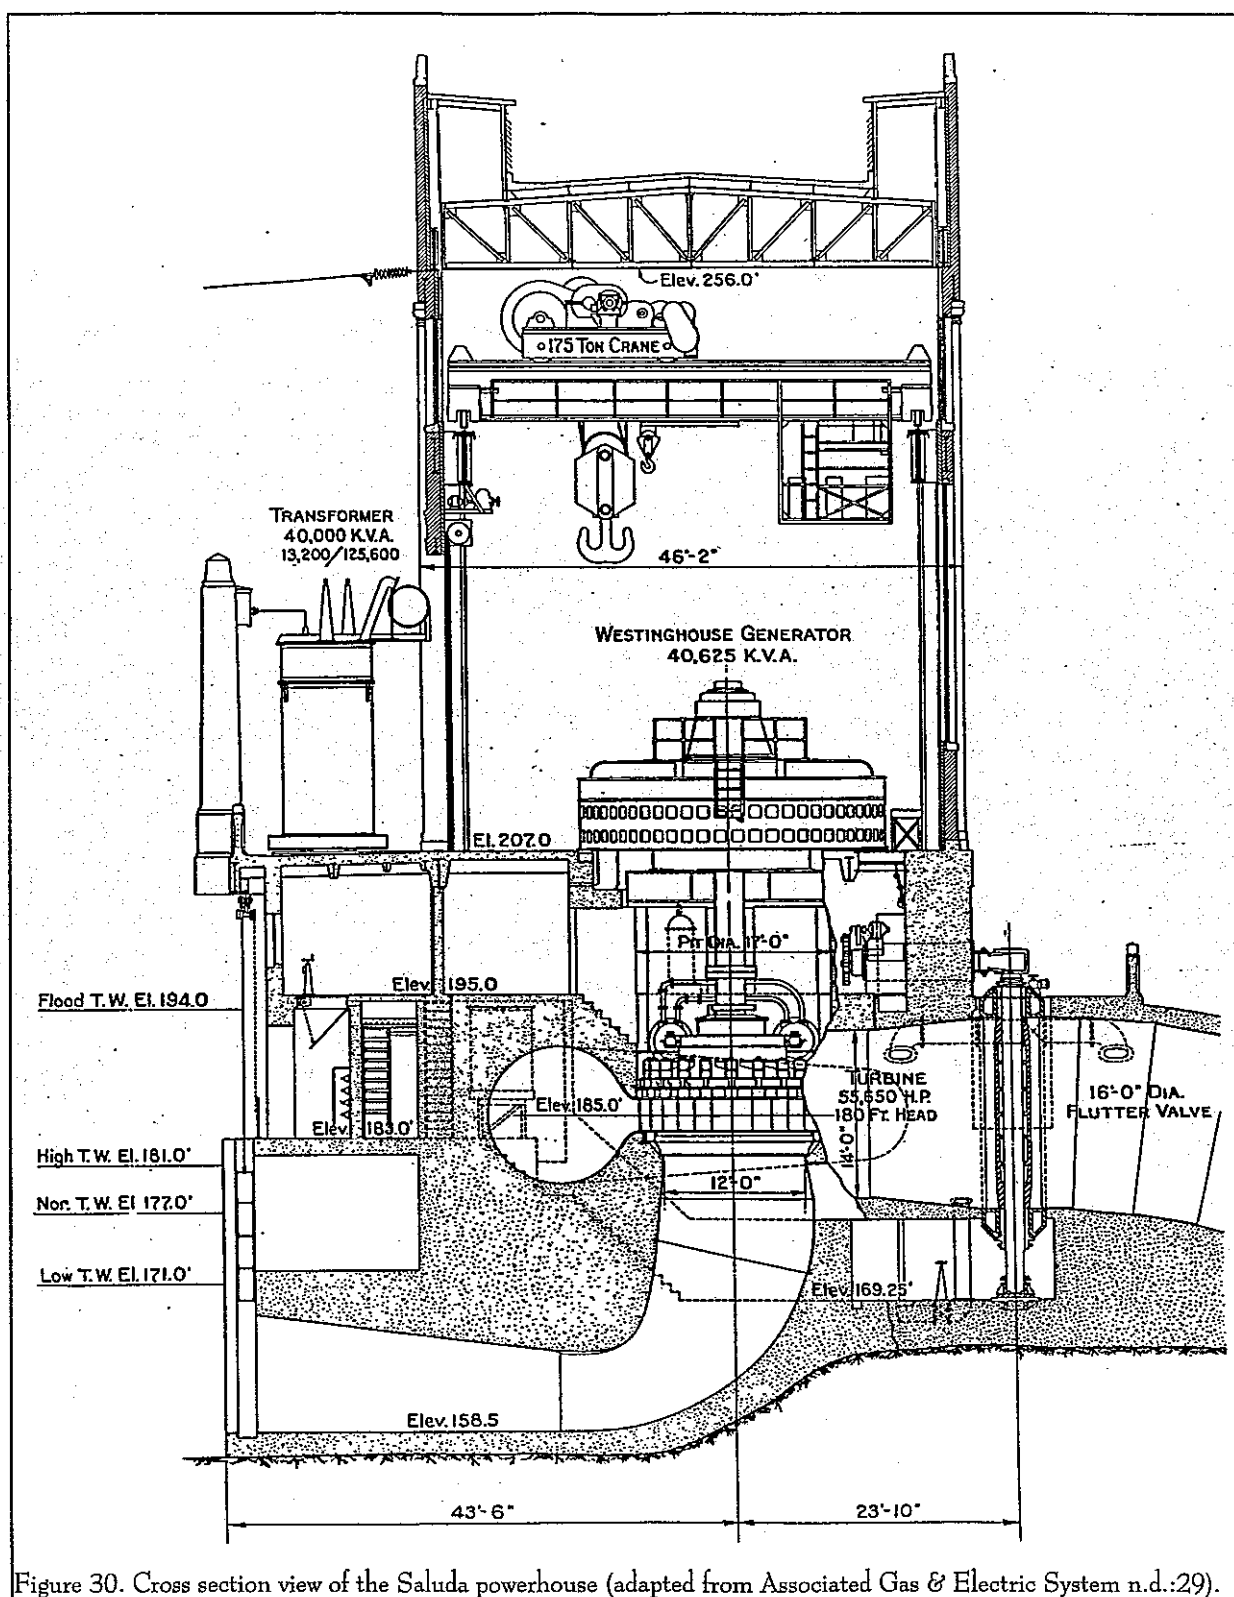
Figure 30. Cross section view of the Saluda powerhouse (adapted from Associated Gas & Electric System n.d.:29).

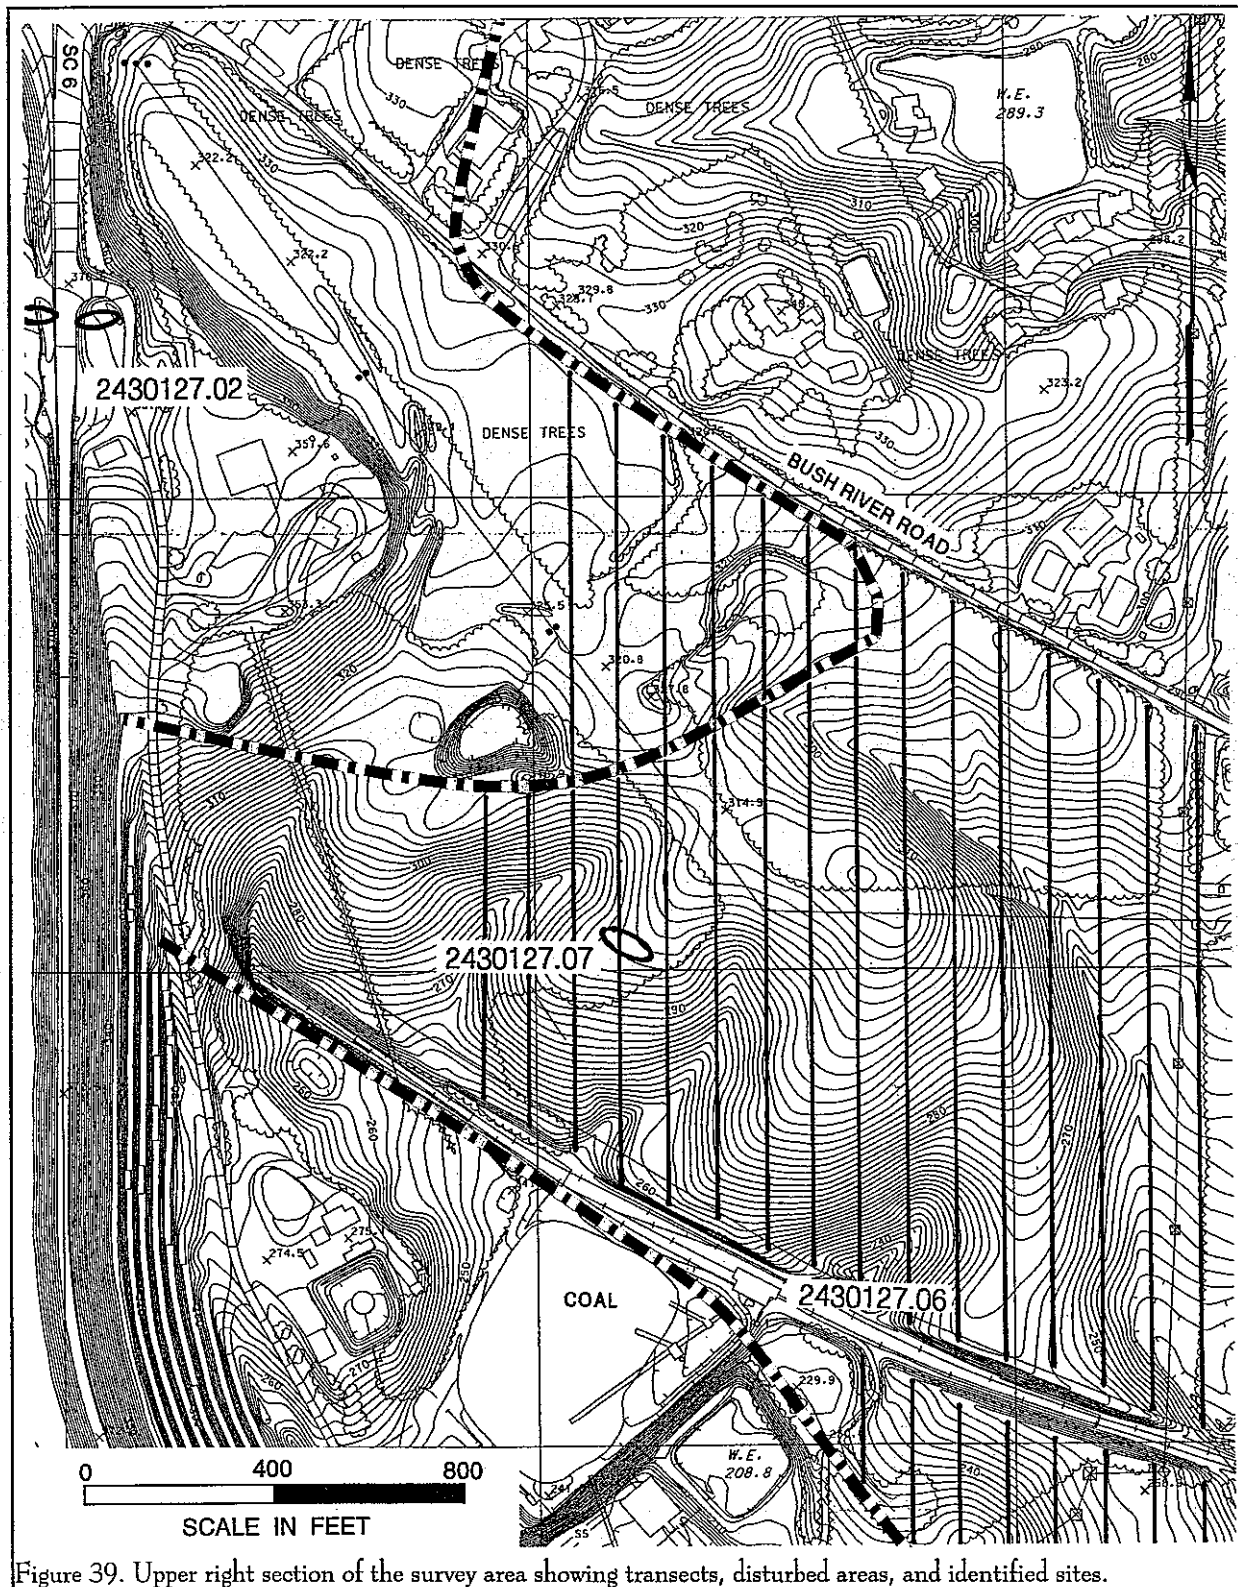
Figure 39. Upper right section of the survey area showing transects, disturbed areas, and identified sites.

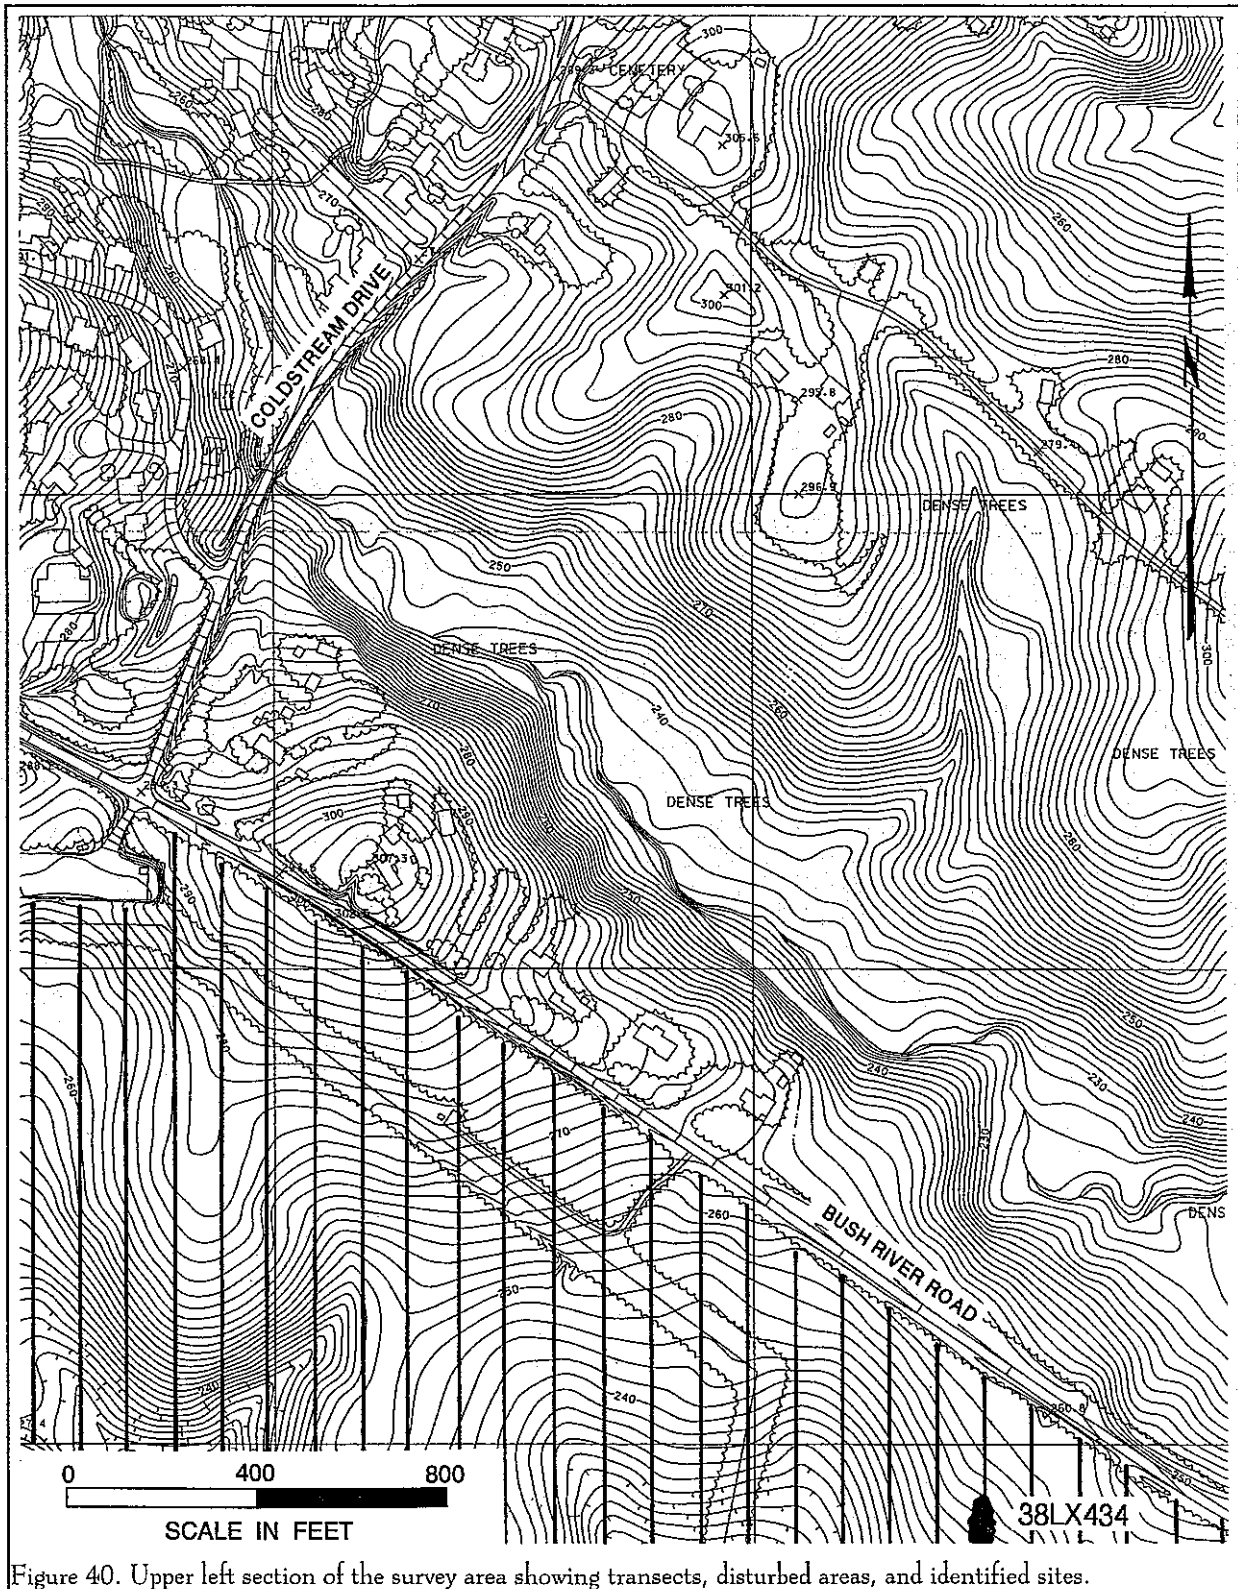
Figure 40. Upper left section of the survey area showing transects, disturbed areas, and identified sites.

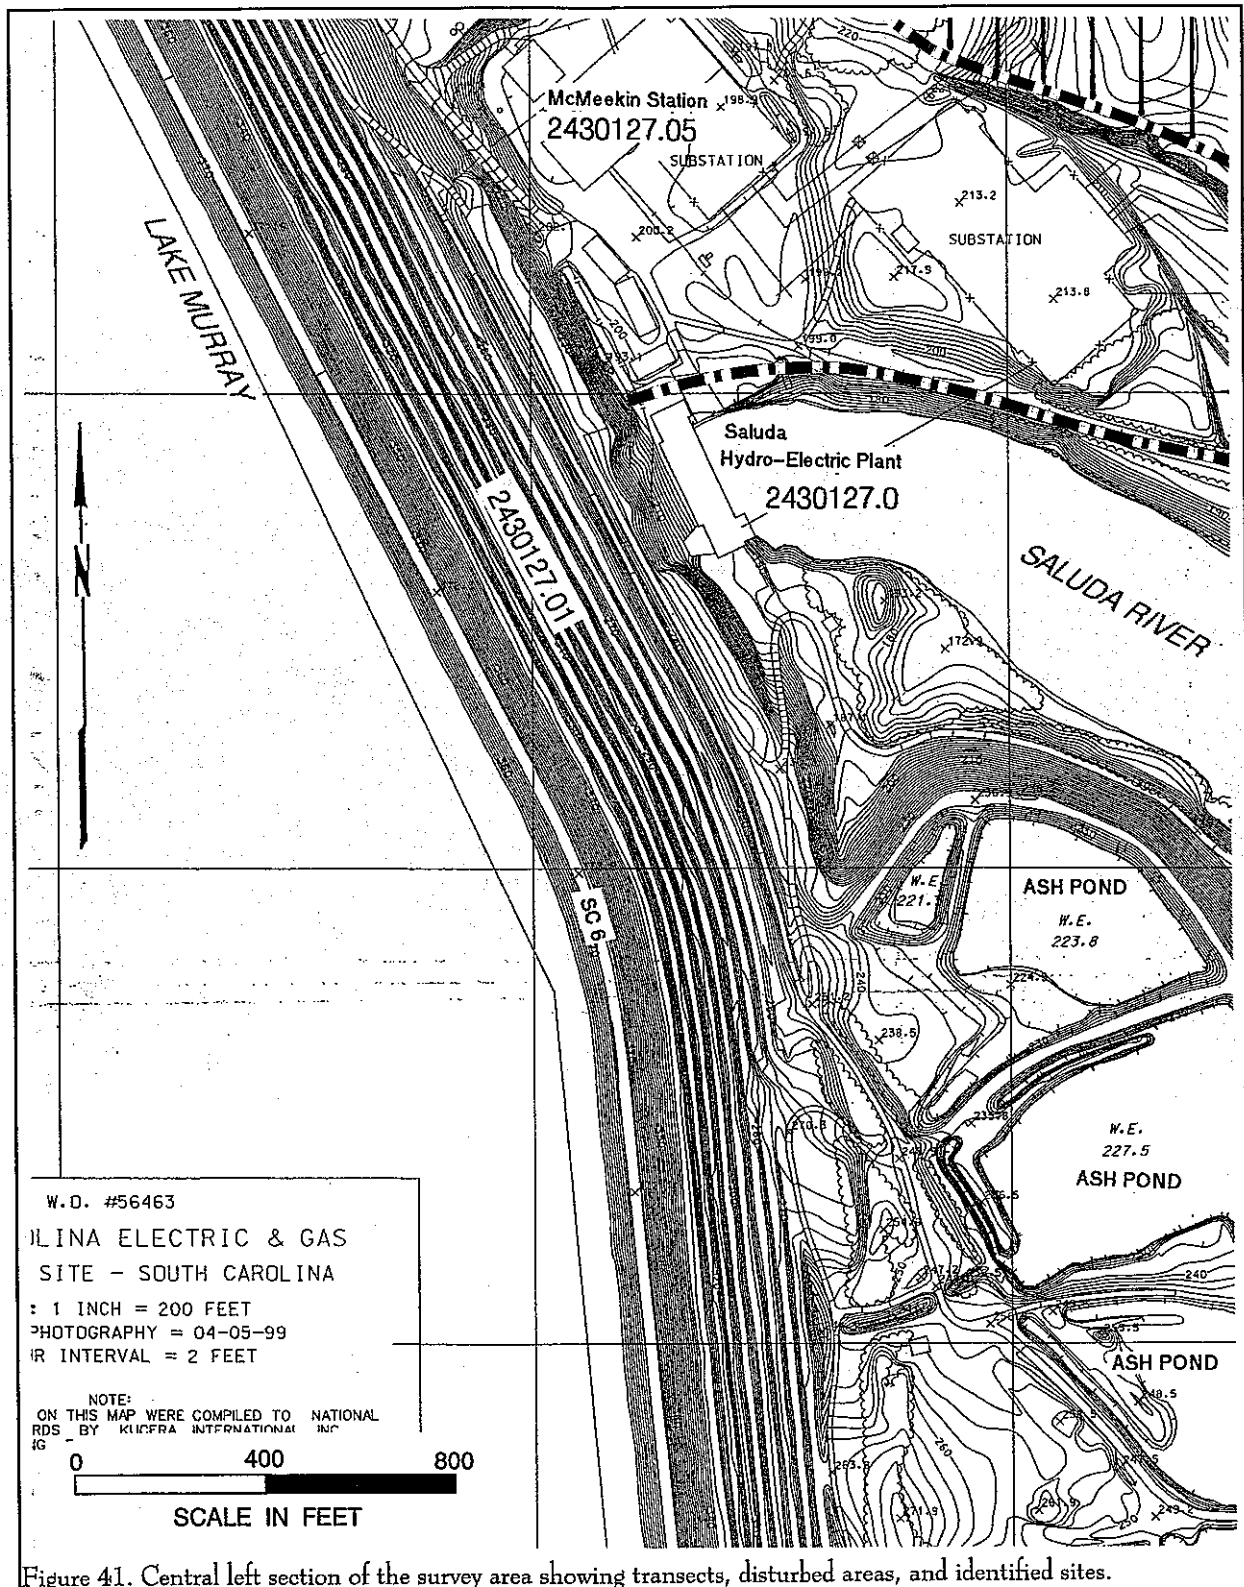
Figure 41. Central left section of the survey area showing transects, disturbed areas, and identified sites.

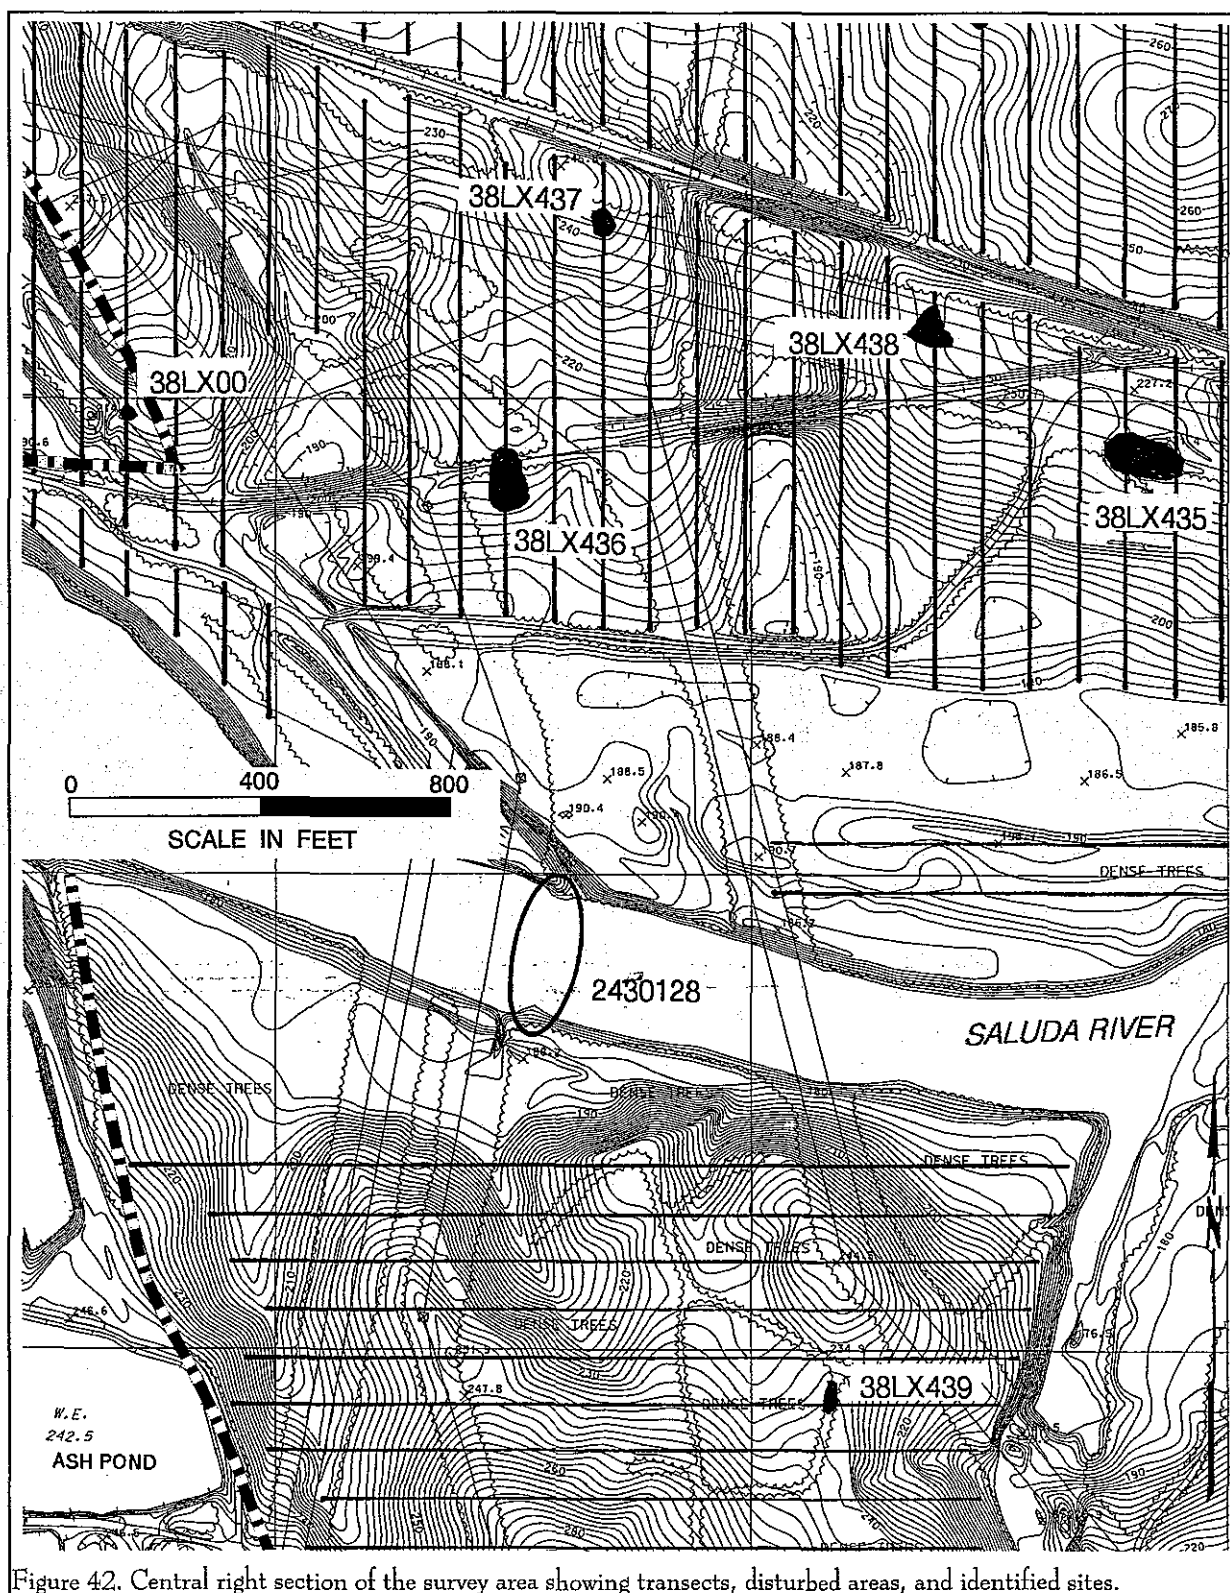
Figure 42. Central right section of the survey area showing transects, disturbed areas, and identified sites.

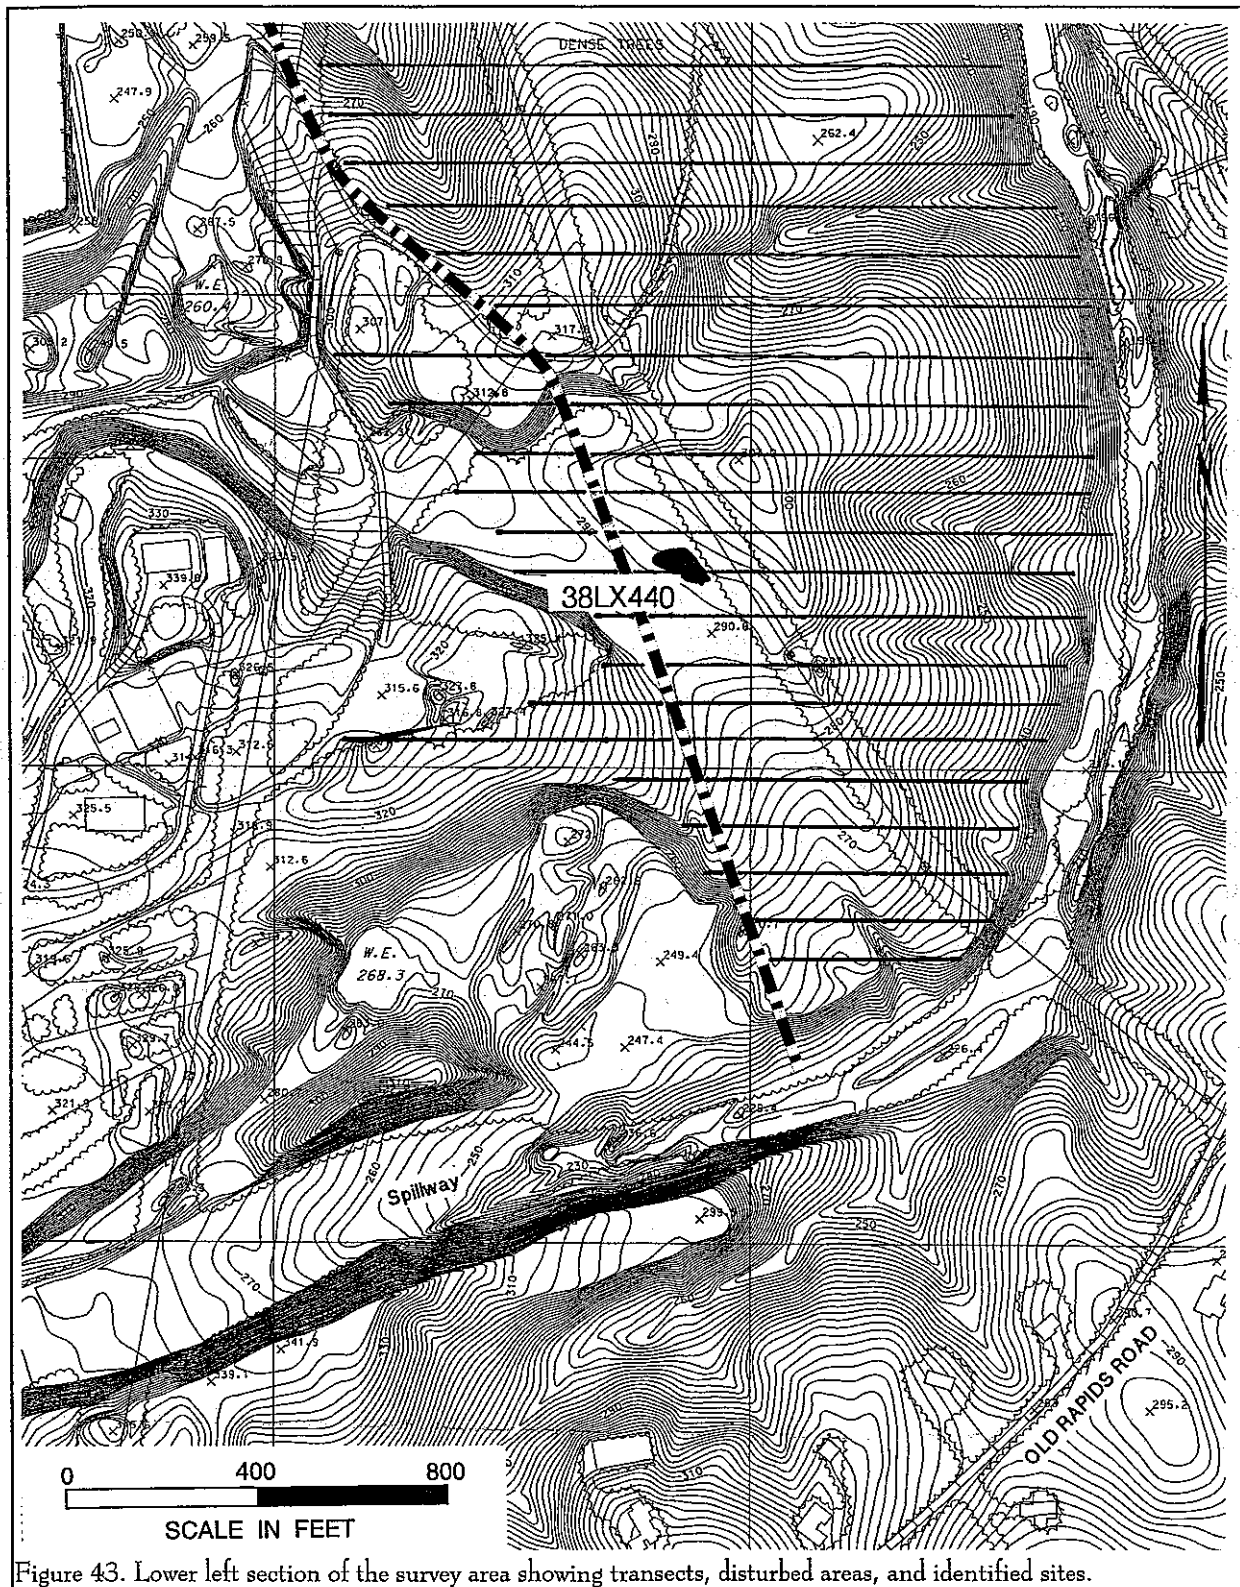
Figure 43. Lower left section of the survey area showing transects, disturbed areas, and identified sites.

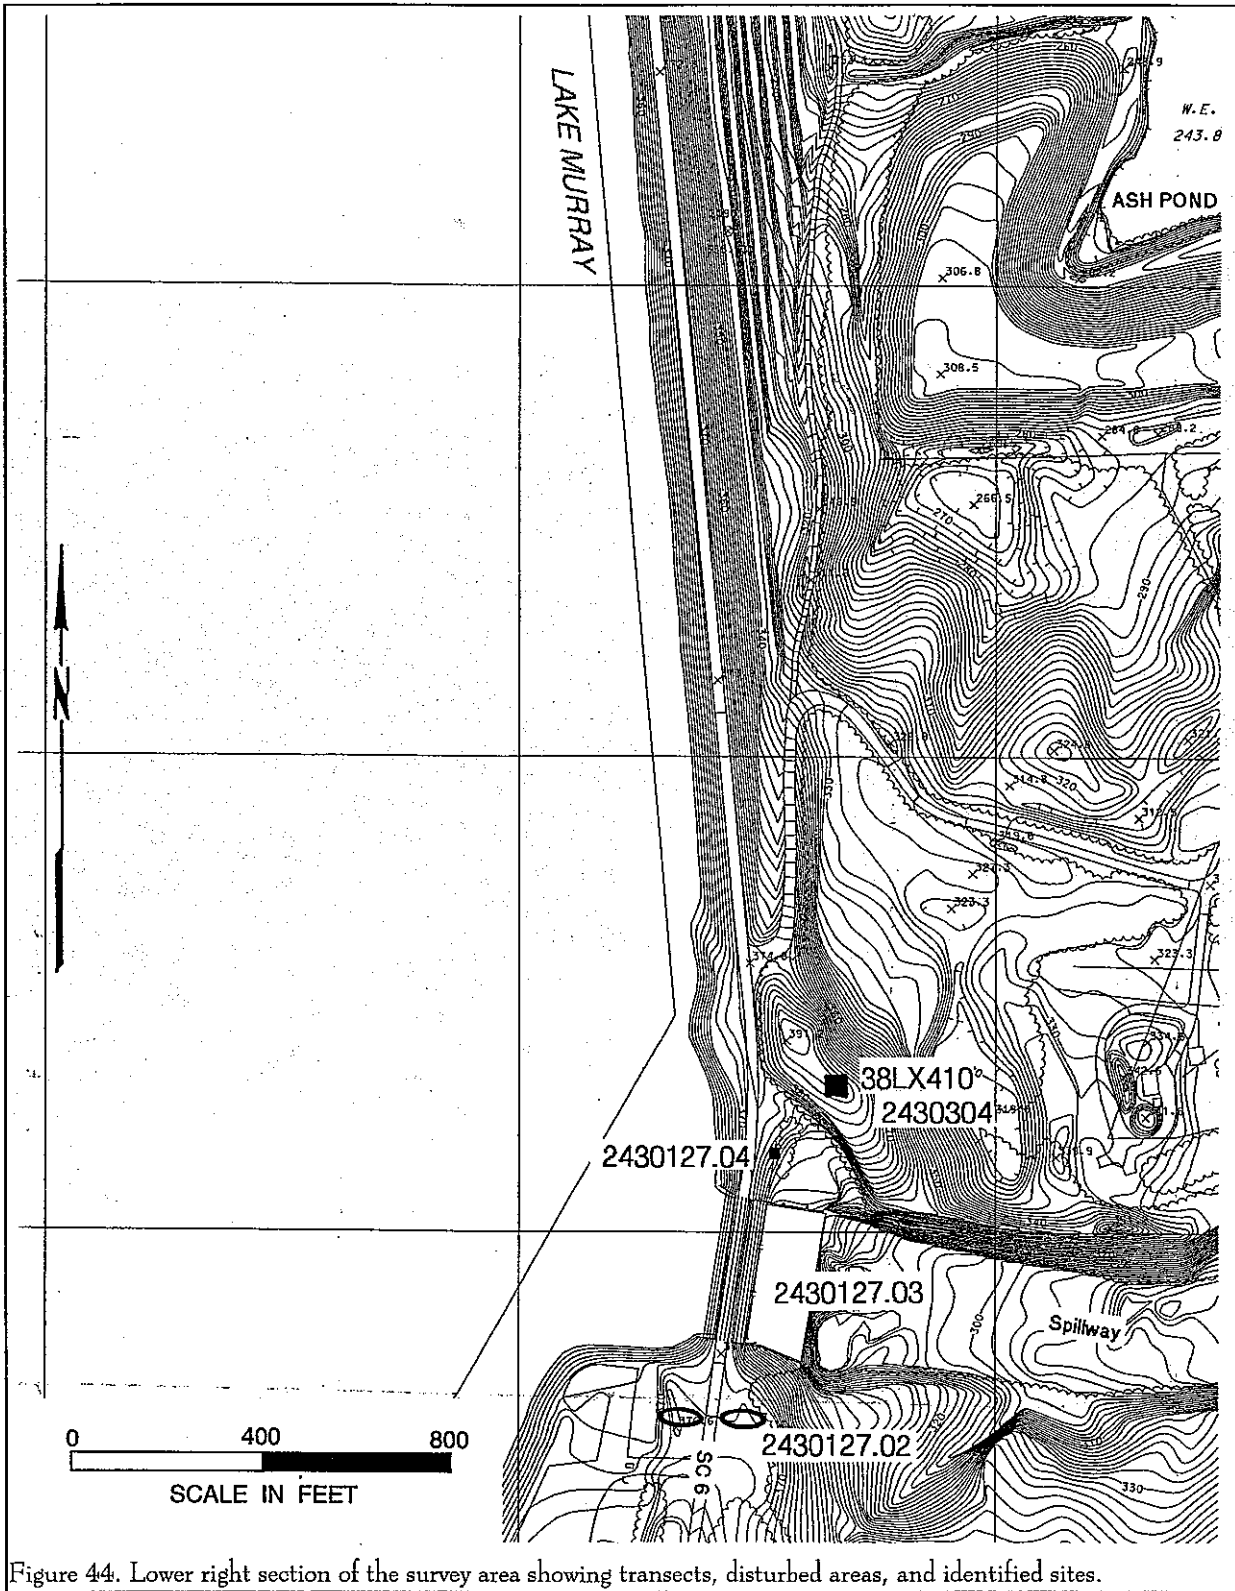
Figure 44. Lower right section of the survey area showing transects, disturbed areas, and identified sites.

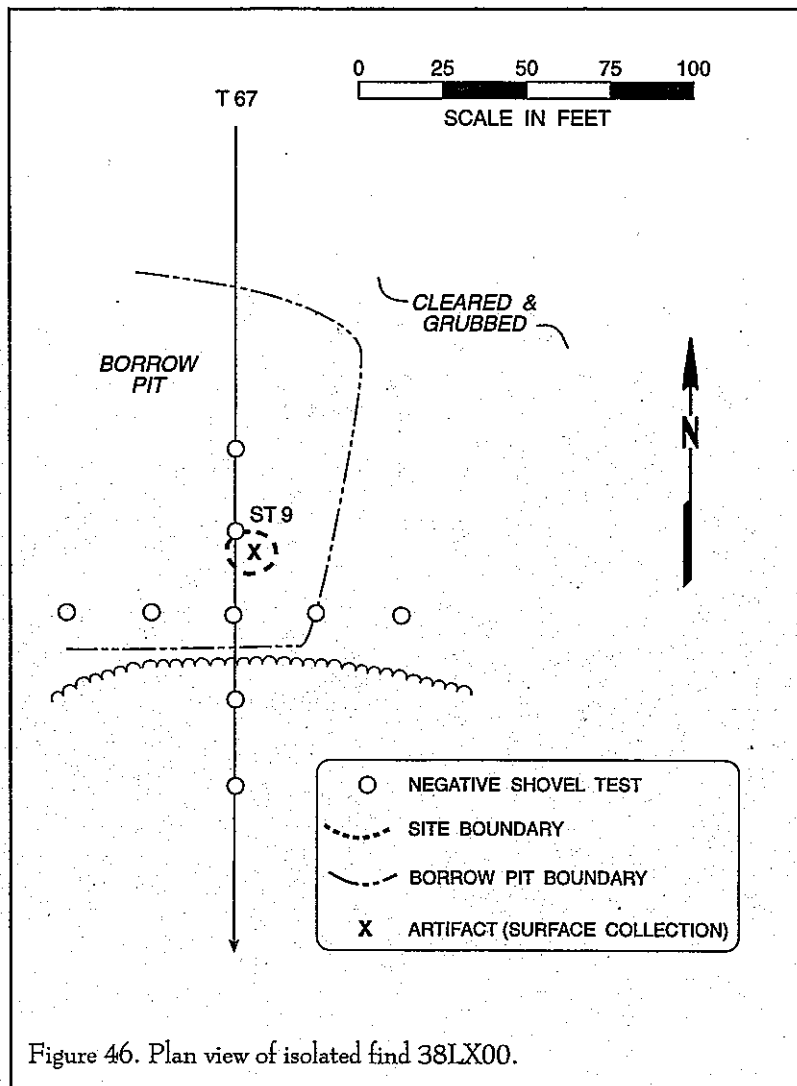
Figure 46. Plan view of isolated find 38LX00.

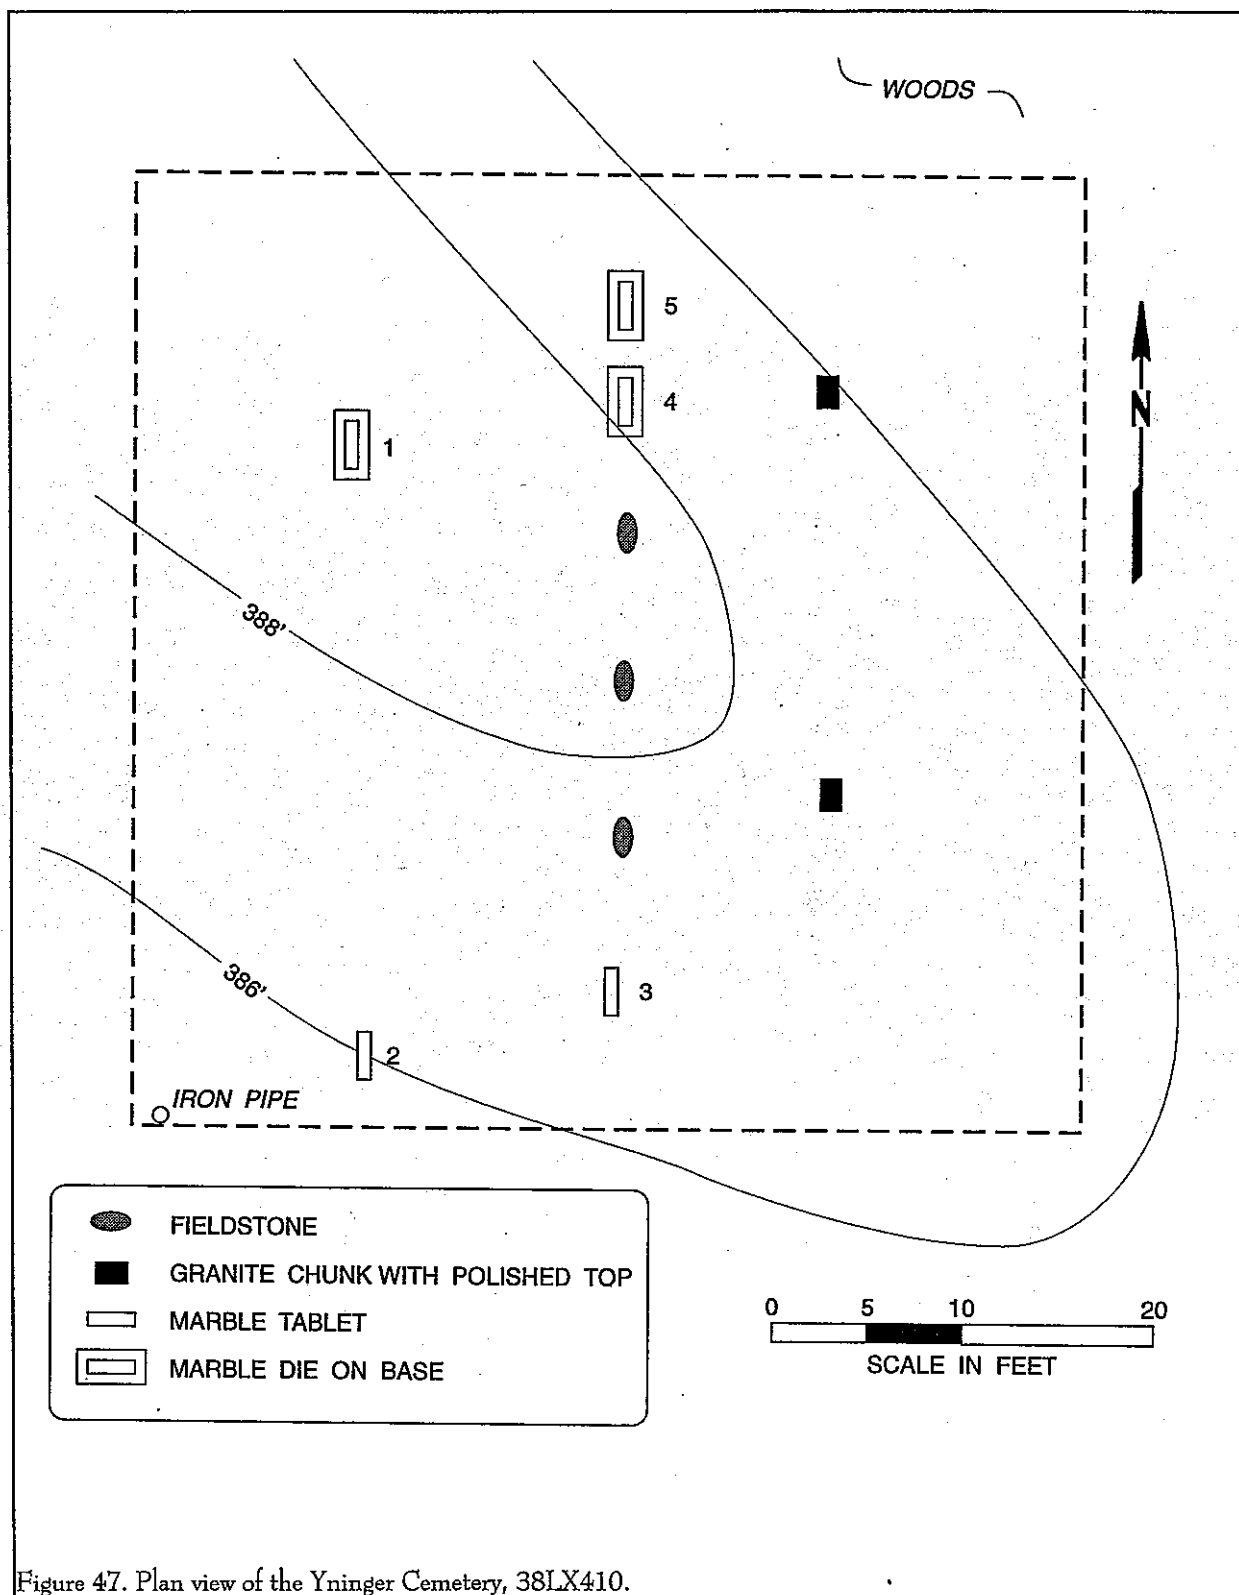
Figure 47. Plan view of the Yninger Cemetery, 38LX410.
